**MARYLAND HISTORICAL TRUST  
DETERMINATION OF ELIGIBILITY FORM**

Property Name: Massey Farm Inventory Number: K-380  
Address: 10197 Augustine Herman Highway City: Chestertown Zip Code: 21620  
County: Kent USGS Topographic Map: Chestertown  
Owner: William and Richard Wiltbank Is the property being evaluated a district? ☐ yes  
Tax Parcel Number: 28 Tax Map Number: 42 Tax Account ID Number: 003675  
Project: Chestertown Emergency Services Tower (Site II) Agency: DBM  
Site visit by MHT Staff: ☐ no ☐ yes Name: \_\_\_\_\_ Date: \_\_\_\_\_  
Is the property located within a historic district? ☐ yes ☒ no

Massey Farm  
Near Chestertown  
1st Quarter 19th Century

## INVENTORY FORM FOR STATE HISTORIC SITES SURVEY

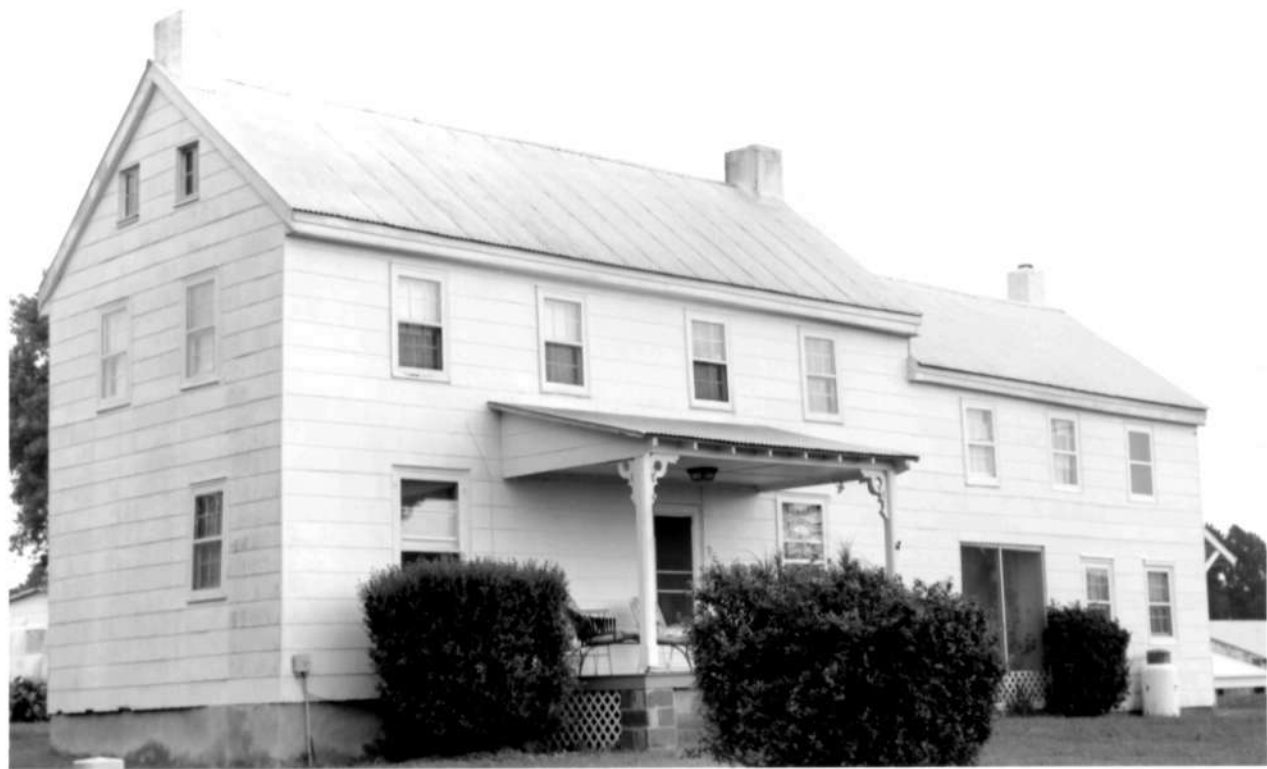
1/4

View of the Facade (South side) of the house.

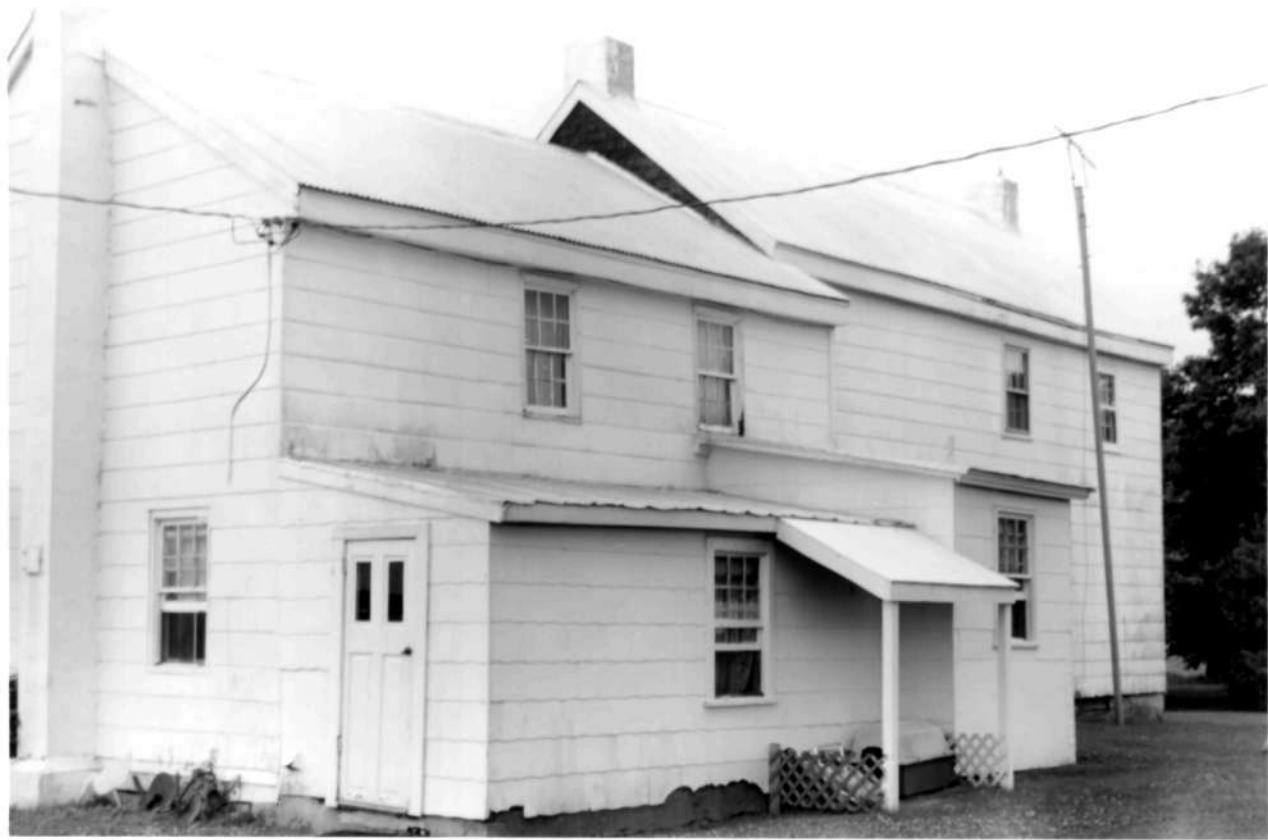
214

View of the north side of the house.

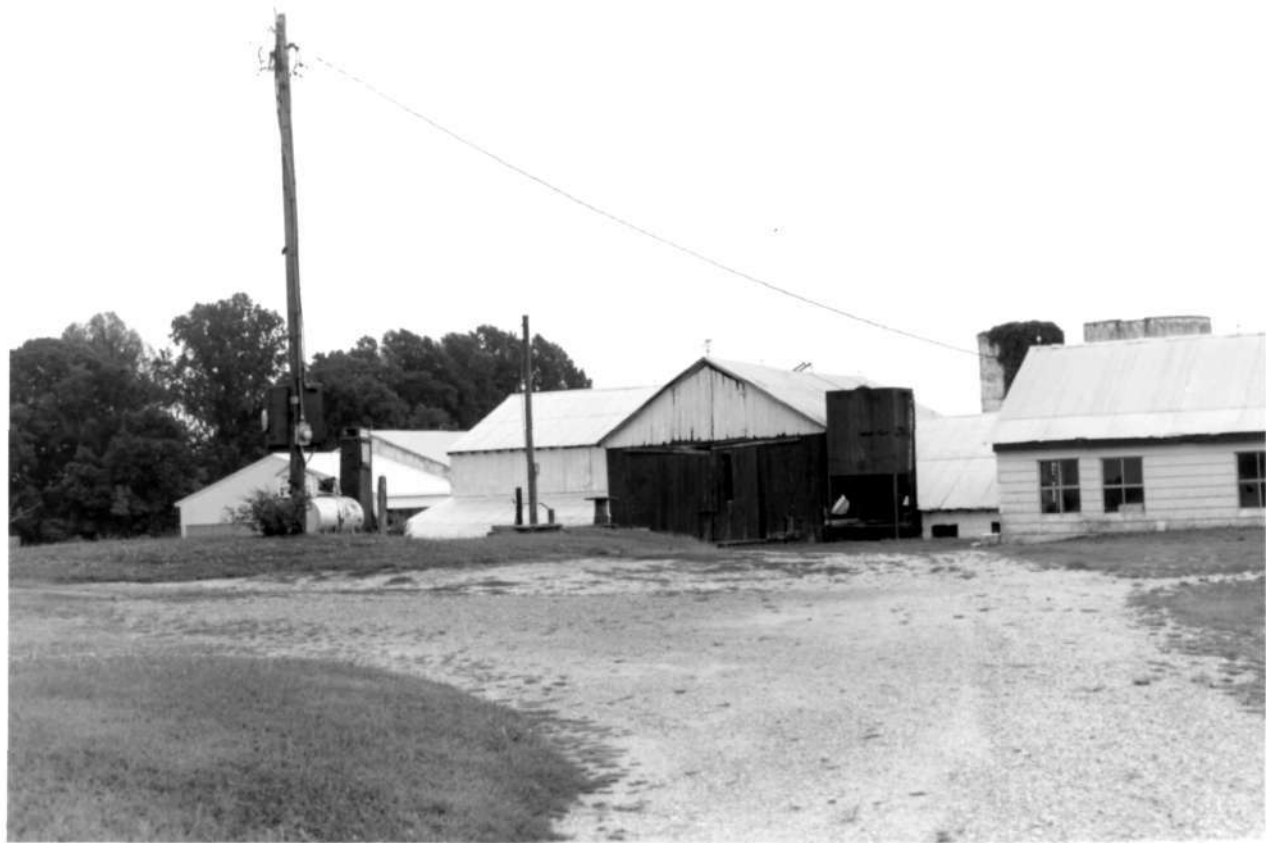
3/4

View of outbuildings looking southeast from  
the house.

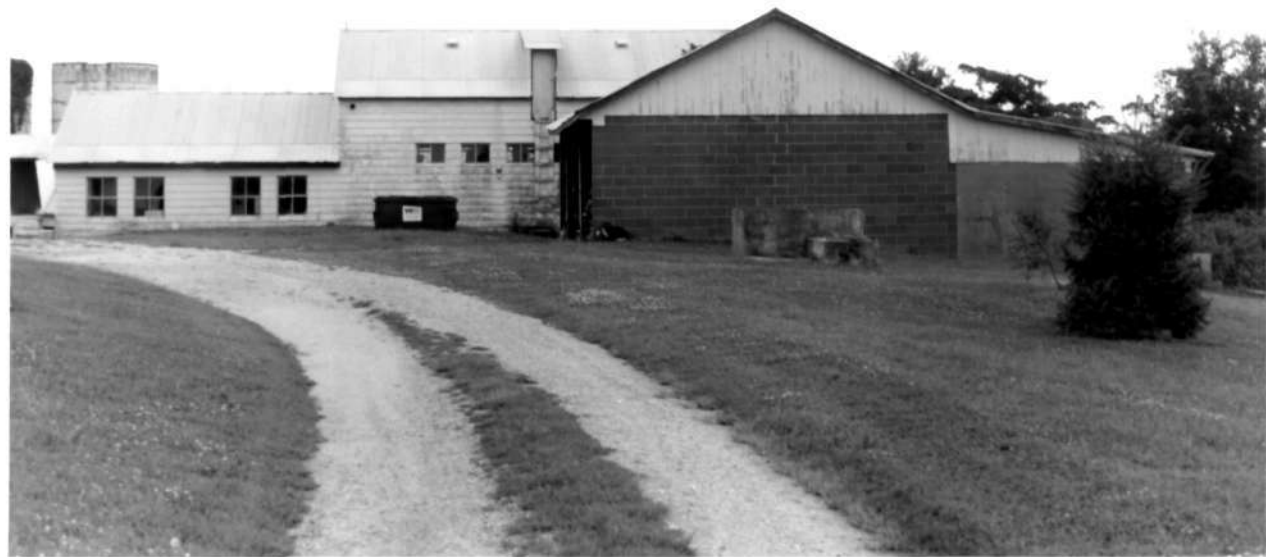
4/4

Additional view of outbuildings looking southeast  
from the house.
